By Leslie Shivers

The section of North Washington Street between 58th Avenue and 70th Avenue was a congested two-lane street serving the industrial area just to the southeast of the I-25/I-76/I-270 interchanges. Drainage was accomplished with side ditches, and ponding and splash-back were issues.

Budgeted at \$7.8 million, this project widened the road to four lanes and improved drainage on Washington Street from 68th Avenue south to the Union Pacific tracks just north of 58th. Nearly two miles of storm pipe, 55 inlets and 33 manholes were installed. New concrete curbs and sidewalks with ADA-compliant curb ramps were built. Pavement was upgraded with concrete intersections and new asphalt. Water lines were relocated and traffic signals were improved.

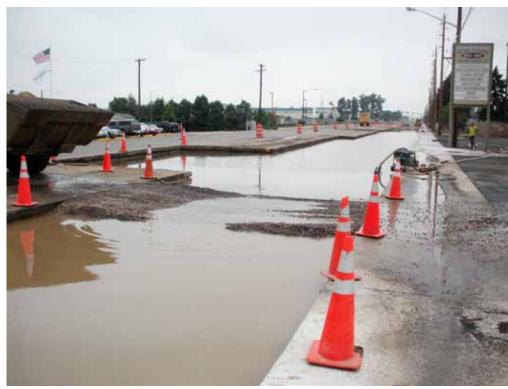
A major rainfall left pools that had to be pumped out prior to resuming construction. (Photo courtesy of Scott Contracting Inc.)

The weather didn't cooperate either. Major rainstorms stopped the work and left standing water that had to be pumped out before work could continue.

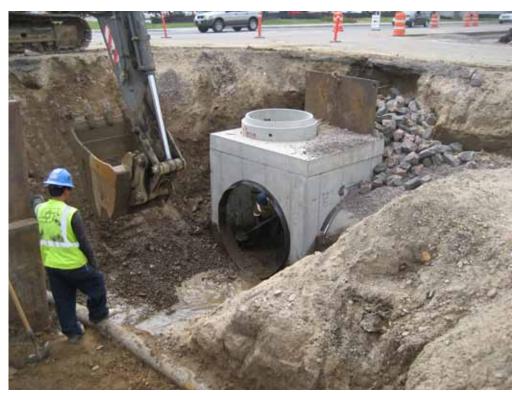
A box base manhole is installed. (Photo courtesy of Scott Contracting Inc.)

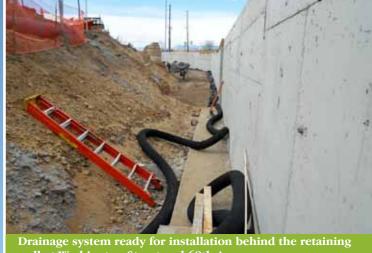
Drainage system ready for installation behind the retaining wall at Washington Street and 68th Avenue. (Photo courtesy of Adams County.)

A retaining wall nearly 500 ft. long and

up to 17 ft. high was constructed at the southeast corner of Washington Street and 68th Avenue. Existing utilities presented challenges, including an 18 in. HDPE pipe delivering irrigation water to nearby farms and Xcel's power-delivery poles.
